PRODUCT BULLETIN 2019

SEEDMASTER ACTIVE WING BRACE

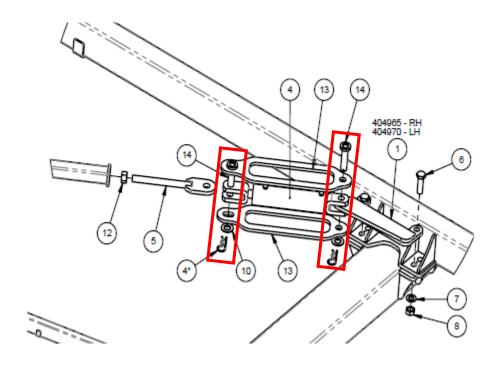
SeedMaster is sending this notice out to all dealers and customers regarding 2018 SM drills with Active Wing Braces. SeedMaster implemented a change for the 2019 production year to manage the risk of the R-clip (#4' in the drawing below) in the cylinder connecting pins (#14) becoming dislodged. If the R-clip is removed or missing, the pins that connect the cylinder to the bracing tube can potentially uncouple. If the Active Wing Brace is non-operational, frame damage is possible. This bulletin is intended to notify SeedMaster dealers, owners, and operators of this change so that existing units can be updated by replacing the R-clips with roll pins. Please follow the procedure below to ensure the update is performed properly.

Procedure: Start by unfolding the SeedMaster drill and then releasing the system pressure. Next, relieve the pressure on the openers by placing the tractor's opener hydraulic circuit into the "float" position. With the opener pressure relieved, remove the current R-clip from the cylinder connecting pins. Ensure you keep the 1" flat washer for reinstallation. With the flat washer in place, install a 7/32" by $1\sqrt[3]{4}$ " roll pin in the bottom of the connecting pins.
